Hail Impact Resistance Testing

Technical Document

Austrian Public Building Insurance Companies (APBIC) Standard

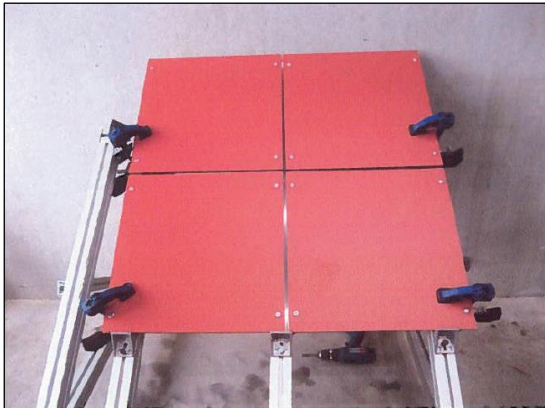
Panels ready for testing

Four panels are mounted and clamped in place to prevent any movement during test.

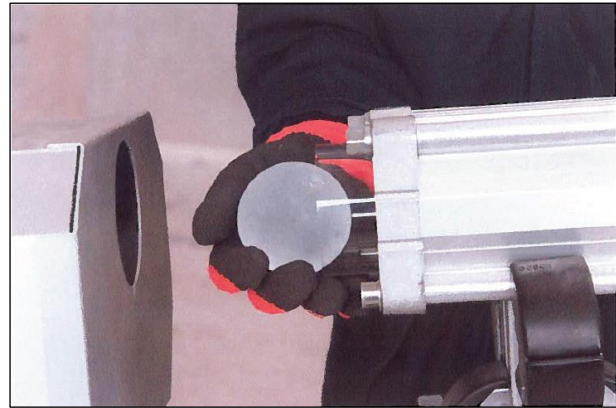
Ice ball being loaded into firing device

Ice balls are laboratory made and must be clear and free of cracks and air bubbles at -4F.

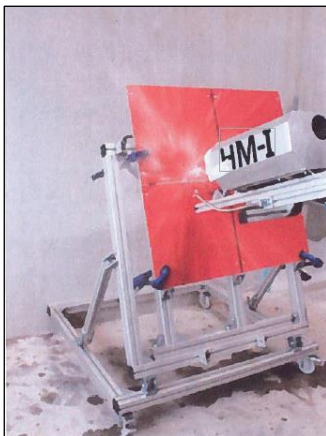
Ice ball being shot at the panels

Ice balls up to 2 3/4” in diameter are shot at Fundermax panels at a speed of 67mph.

Distance of firing gun and target area is between 15” to 20”.
